# Connecticut Property Engineering

October 11, 2019

RE: Walnut Beach Condominium Association Lintel Uplift and Other  
Miscellaneous Items

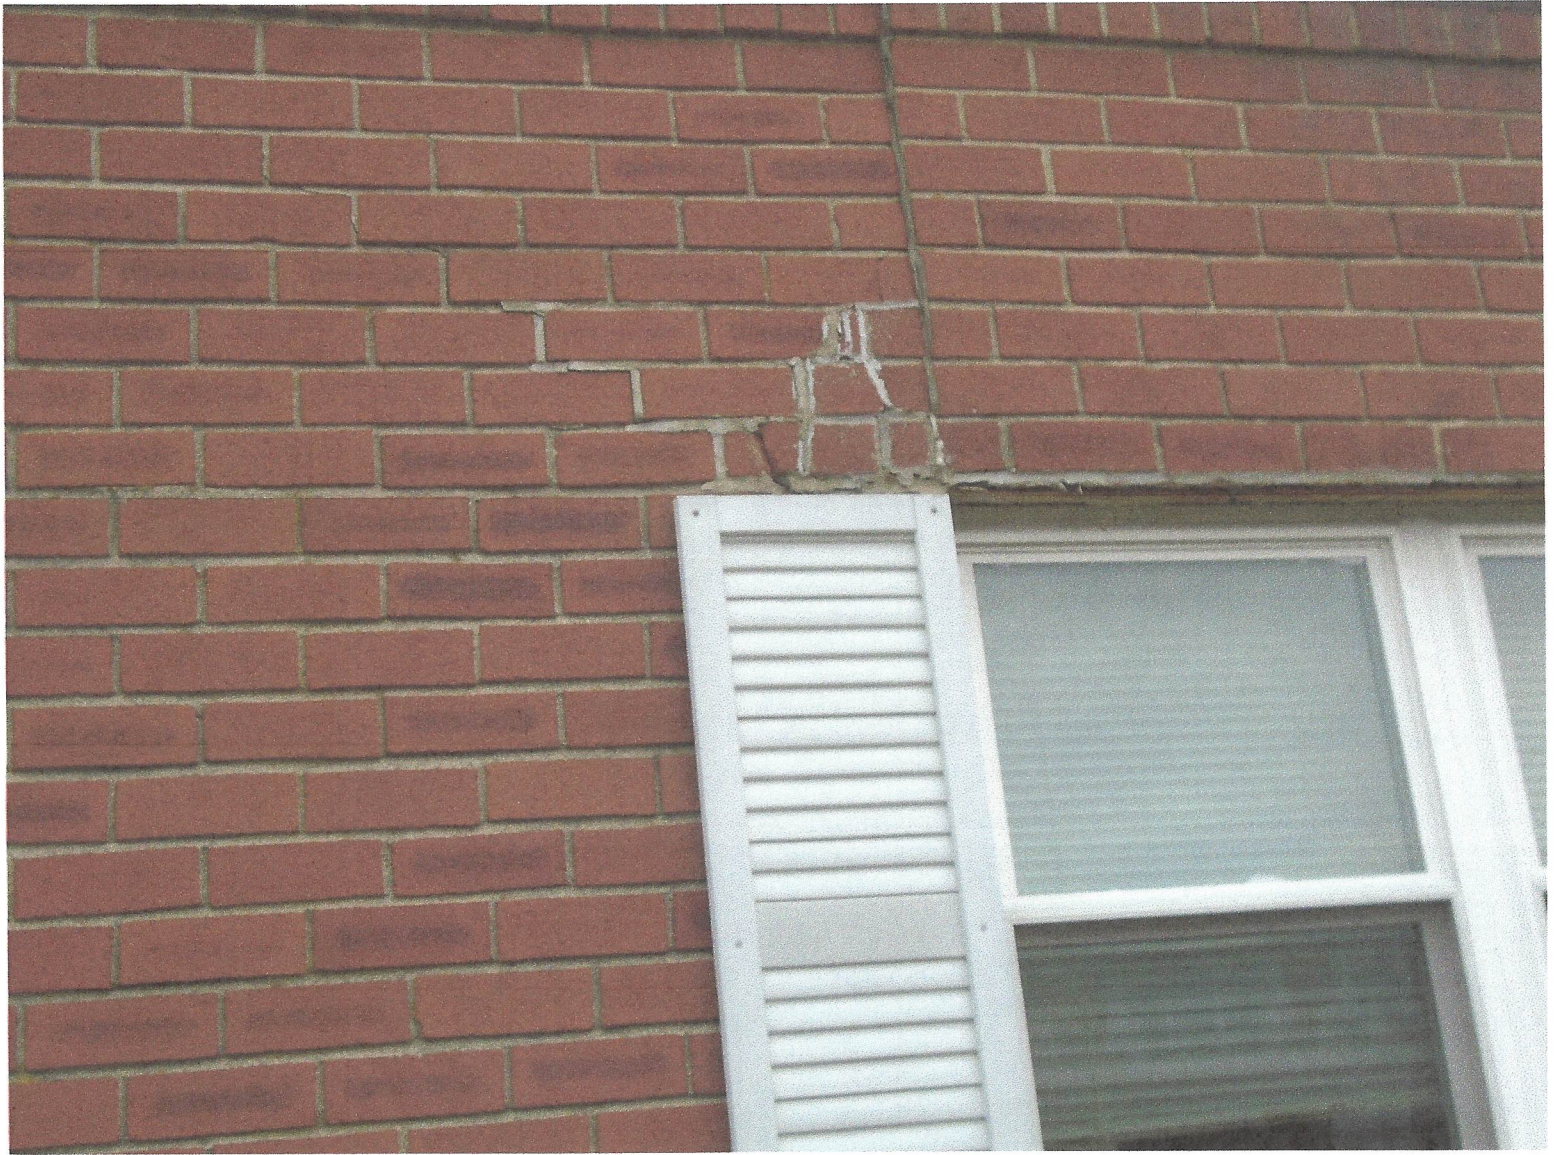
As we discussed during our recent visit to review several items of concern at the Walnut Beach Condominium Association, this brief report is intended to delineate some of our concerns and potential repair methodologies, in particular the problem above many of the windows in the brick part of the complex. The issue with these areas is a phenomenon called lintel uplift. To better explain this, the lintel is a piece of angle iron, typically around 4-inches by 4-inches, that is used to hold the brick that sits above a window or door opening. Often this is attached to the underlying framed wall, but in some cases it is merely resting on top of the adjacent bricks. What happens with this phenomenon is that the steel in the lintel corrodes, creating iron oxide which has a greater volume than the original steel due to the oxidation process which forms a different lattice structure within the material. This causes an expansion somewhat similar to what happens when water freezes and turns into ice. This can then either lift the bricks above this area or in some cases push the center of the lintel down. One can readily observe this phenomenon in many of the bridges on the Merritt Turnpike where you can see large flakes of concrete have come off, and you can observe the underlying reinforcement which in the case of the Merritt Turnpike bridges was not coated rebar as is now generally used. Photo D shows this phenomenon at this complex on one of the window sills. Photos A and B show the phenomenon where it is lifting at the corners of the window and Photo C shows one where instead of lifting on the corners, it is pushing down in the center. It should be expected that this phenomenon will continue as the rusting of the lintels progresses.

Typically what is done to remediate this problem is that a couple rows of bricks are removed above the lintel, the lintel is then taken out and replaced with a galvanized steel lintel. Then the bricks are either reused or replaced above the area. We do have a concern that in many cases the bricks above the lintel may not be very stable and the project could grow in scope if the bricks above the removed ones do not stay in place during this process, which would then require a greater amount of removal. Further, many or most of

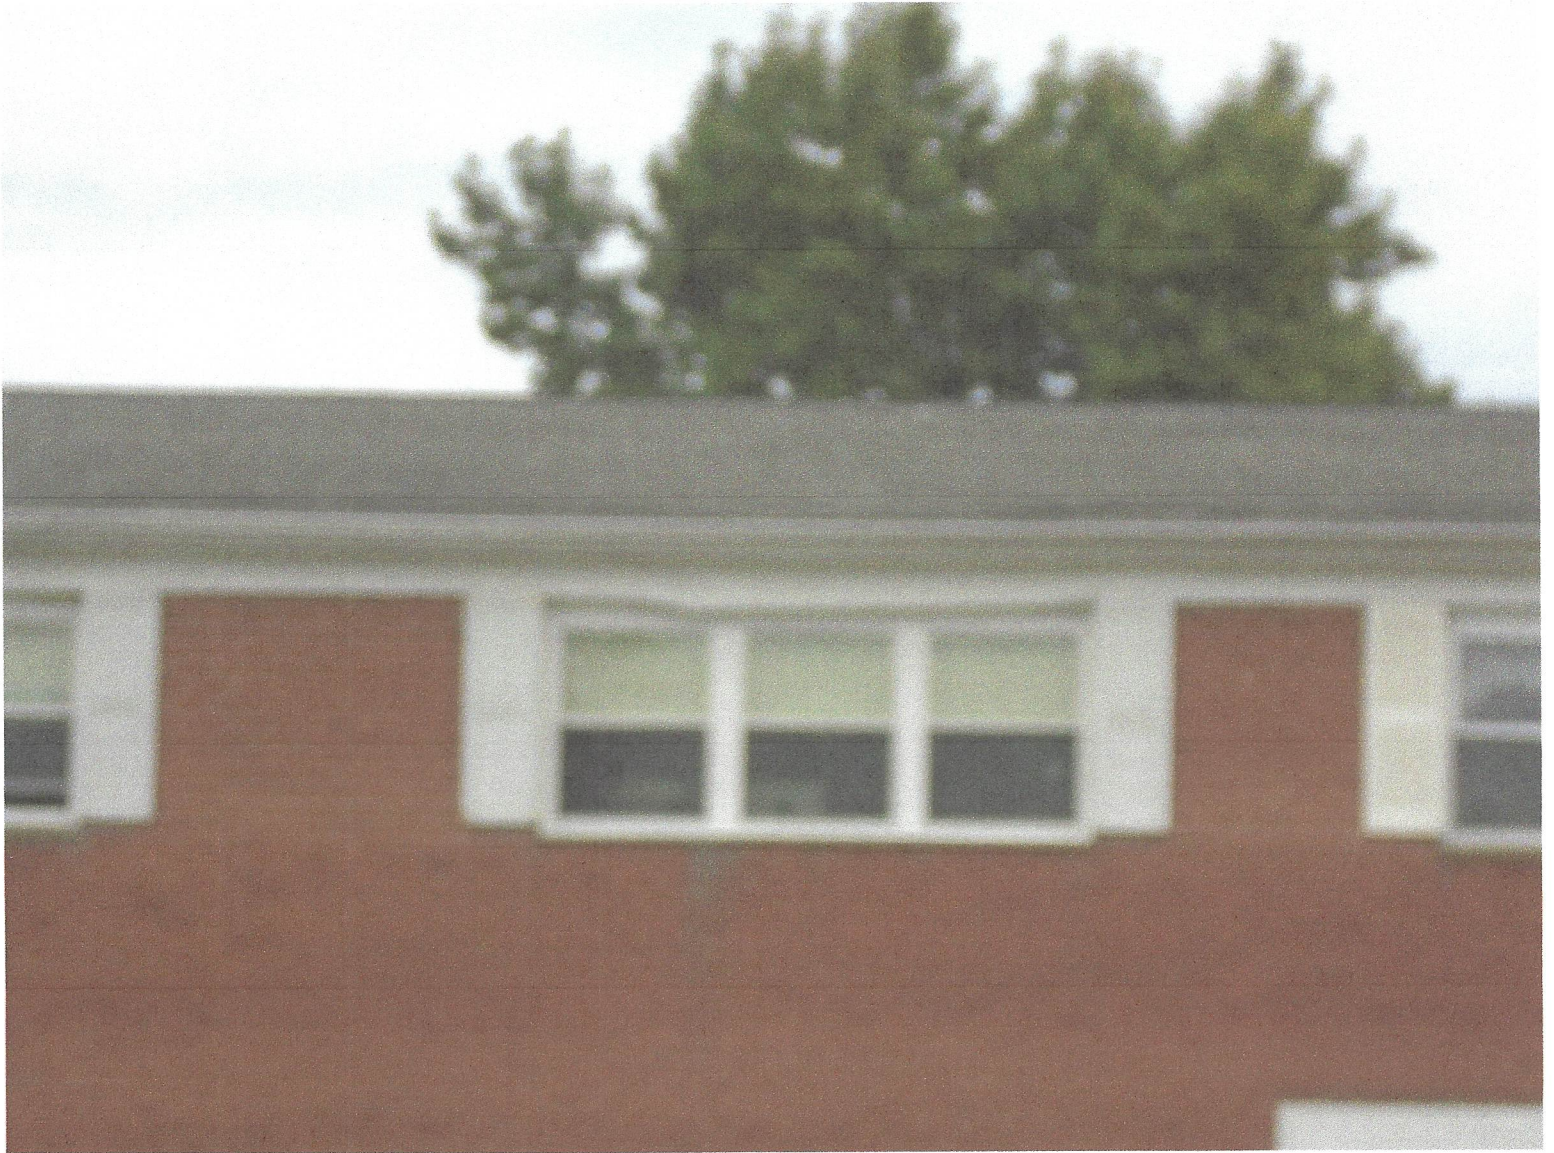
F

Another ongoing issue that we discussed is the window header sagging which can be seen in photo F, albeit not the best photo. There is a sagging over the large windows in many areas which is evidenced by the roof line as well as the window trim. As you know and we have discussed for quite a few years this problem is not new, but does appear to be slowly progressing. I believe based on what we found in the past the windows have a header set back from the outside of the brick and the trusses were then placed over that extending outward, but were not placed at the appropriate load point on the truss which then creates this sagging lip which extends over the building. This should be investigated further, but I suspect based on some of the reviews we have done in the back areas, likely this could be jacked and plywood plated, albeit may be requiring lifting of plywood to gain access in these areas. Perhaps the best way to deal with this is to keep in mind that this needs to be resolved and when any roofs are done, this could be done far easier.

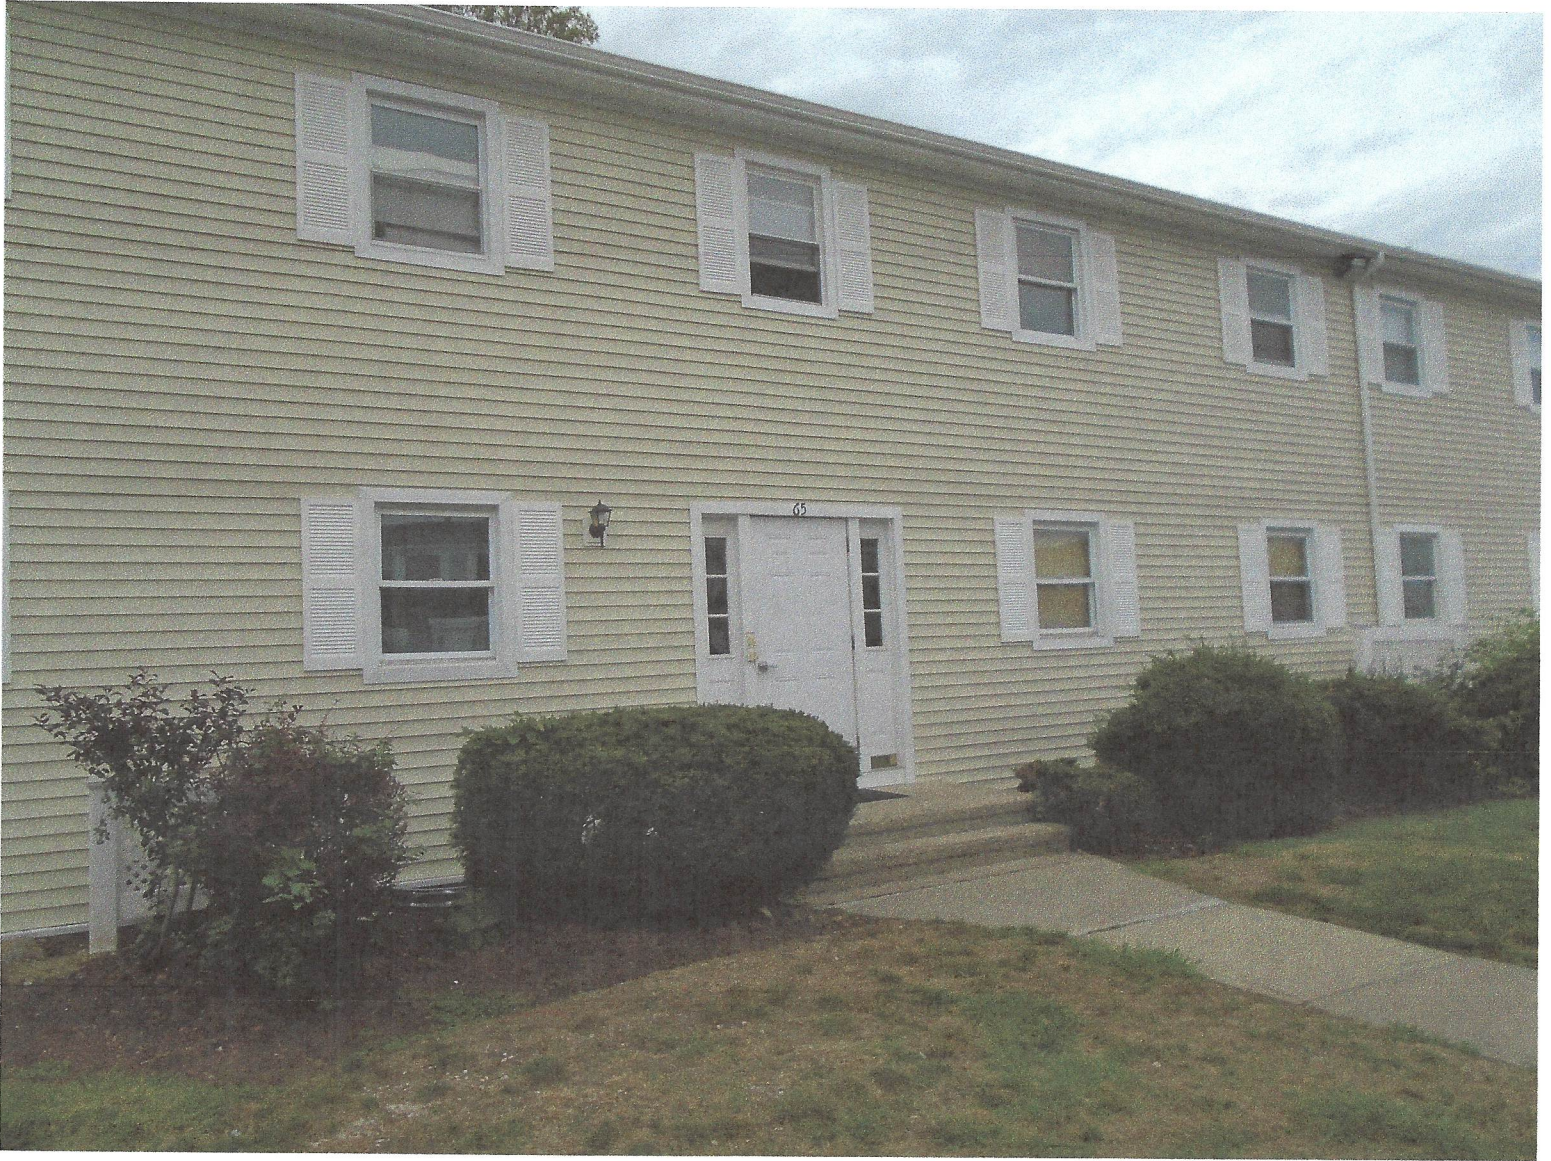
G

With regard to the ongoing deflection and settlement in the basement units that we have discussed many times, I believe that this somewhat needs to be done on a priority basis as discussed in our earlier reports, as some of the basements as you well know are in far worse shape than others and this appears to be directly related to moisture levels. In some cases more major repair like the ones that were done recently are appropriate or in some cases simply reinforcement or intermediate span beams can be a simpler solution, but
